Feasibility Study: Demolition of Cal Poly's “Powerhouse”

Evan W. Tookey

California Polytechnic State University
San Luis Obispo, CA

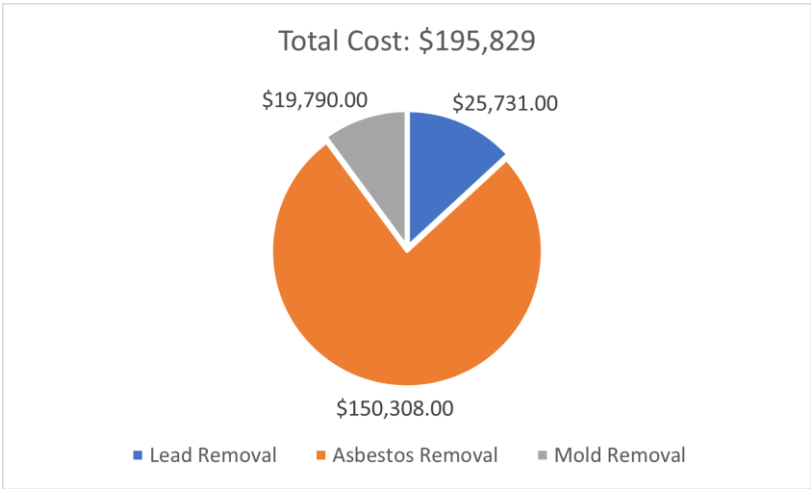
Figure 3: 2005 Estimated costs for Hazardous Material Removal

Figure 3 shown above gives an accurate estimate from 2005 on the cost of removing all hazardous materials from the building, prior to renovation. With the addition of the design, packaging, and trucking costs, the removal and disposal 2005 estimate came out to be around \$270,000. Knowing that this estimate was created in 2005, \$270,000 back then would be around \$382,380 today (Inflation calculated through officialdata.org). These numbers however still do not account for the damages and hazardous materials and wildlife that may have infested the building within the past 16 years.

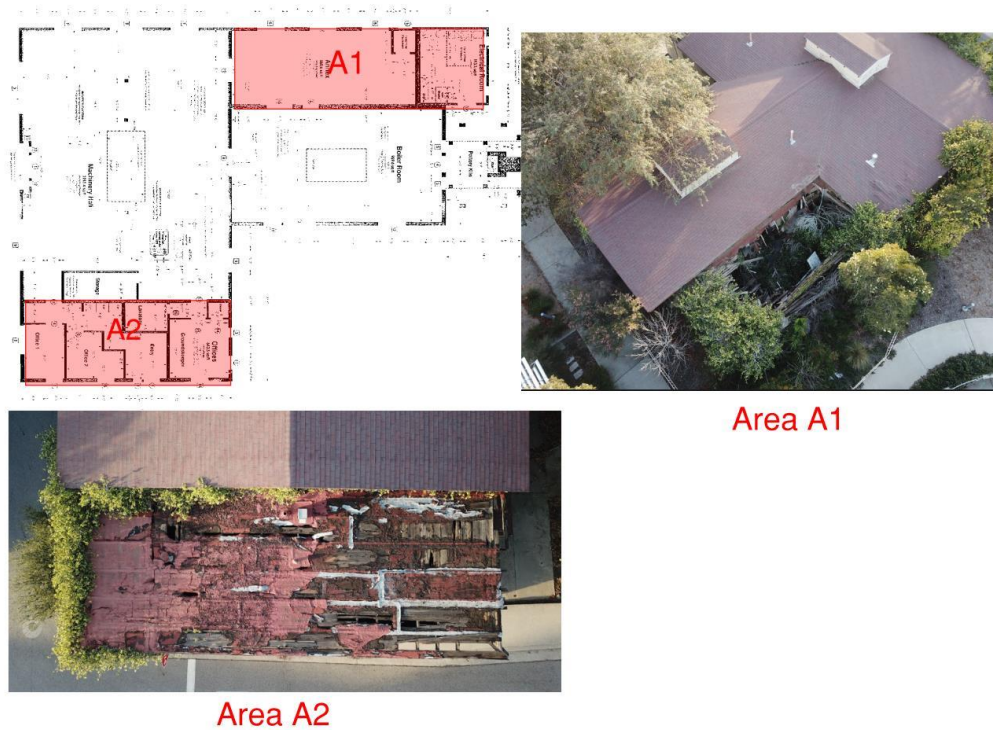
I also believe demolition should be preferred over renovation, as there is a vast amount of existing damage throughout the building due to natural, environmental causes. Specifically, there is a considerable amount of damage to the roof in 2 separate areas as shown in Figure 4. These 2 areas of roof collapse were caused by the large amount of rain received in San Luis Obispo in the Winter of 2018/2019. In 2005, there had been an estimated cost \$3,003,000 to completely renovate both the structural envelope as well as the interiors. At the time, RRM states that, "The costs referenced are based upon 2005 data and are not firm construction estimates, as no in-depth design or construction documents have been completed. RRM has been very clear in identifying the number of unknowns and challenges in this renovation". With 15 years of inflation, that cost would be close \$4,250,000 with still many unknowns and challenges to overcome. Despite many of the administrations hopes of reviving this old building, the costs seem to far outweigh the benefits in terms of renovation.

Figure 4: Areas of Roof Collapse due to rain

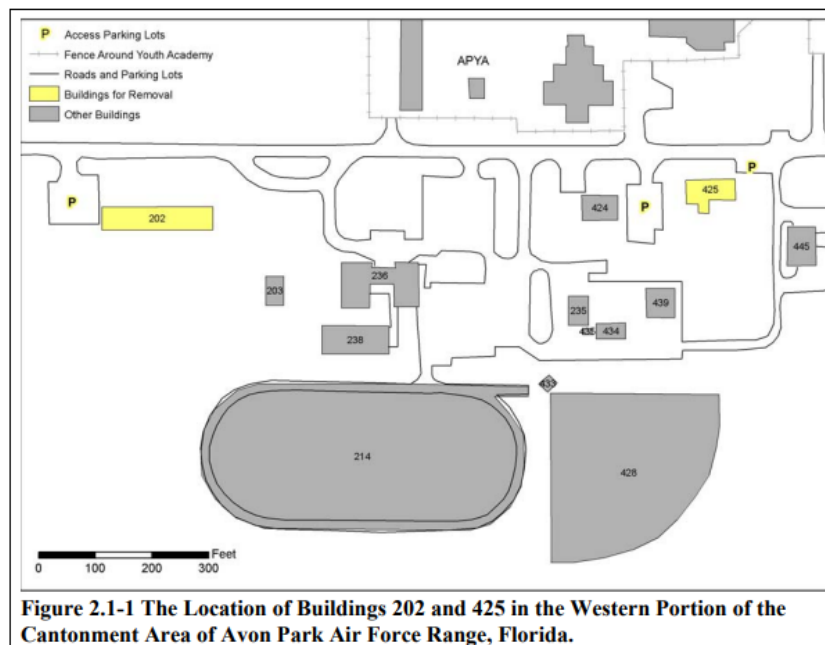
Another similarity between this project and Cal Poly's Powerhouse is that the two Air Force range buildings contain both asbestos containing materials and lead based paint. However, these two buildings will be removed by using heavy equipment consisting of a backhoe/nibbler and haul trucks. Looking into the surrounding areas of these buildings, unlike the Powerhouse, there is not nearly as many occupied facilities surrounding them which can allow them to use heavy equipment for demolition (Shown in Figure 5).

Figure 5: Map showing the 2 abandoned buildings
